DEPARTMENT OF TRANSPORTATION

Contract #: 04-0120F4Cty: SF/ALA Rte: 80 PM: 13.2/13.9File #: 69.28**WELDING INSPECTION REPORT****Resident Engineer:** Pursell, Gary**Address:** 333 Burma Road**City:** Oakland, CA 94607**Report No:** WIR-015515**Date Inspected:** 11-Jul-2010**Project Name:** SAS Superstructure**OSM Arrival Time:** 700**Prime Contractor:** American Bridge/Fluor Enterprises, a JV**OSM Departure Time:** 1900**Contractor:** Zhenhua Port Machinery Company, Ltd (ZPMC), Changxing Island **Location:** Shanghai, China

CWI Name:	Li Yang and Wu Zhi Cheng	CWI Present:	Yes	No
Inspected CWI report:	Yes No N/A	Rod Oven in Use:	Yes	No N/A
Electrode to specification:	Yes No N/A	Weld Procedures Followed:	Yes	No N/A
Qualified Welders:	Yes No N/A	Verified Joint Fit-up:	Yes	No N/A
Approved Drawings:	Yes No N/A	Approved WPS:	Yes	No N/A
		Delayed / Cancelled:	Yes	No N/A
Bridge No:	34-0006	Component:	OBG Trial Assembly

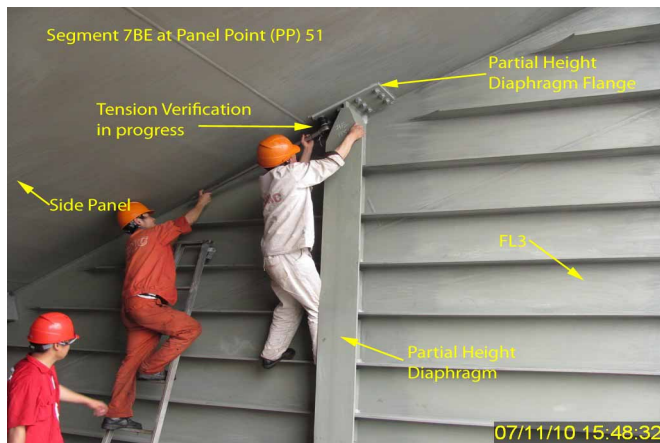
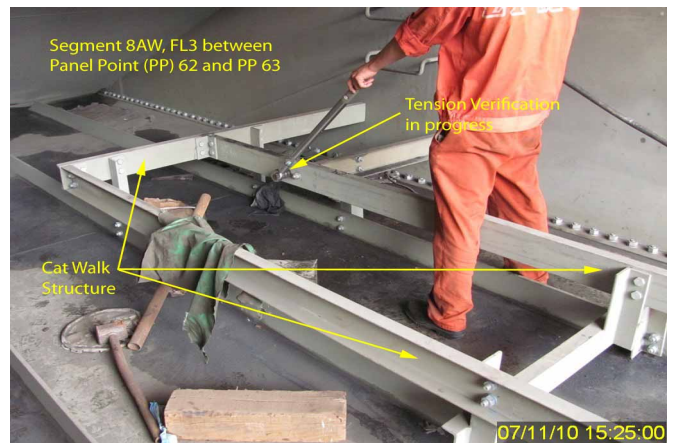
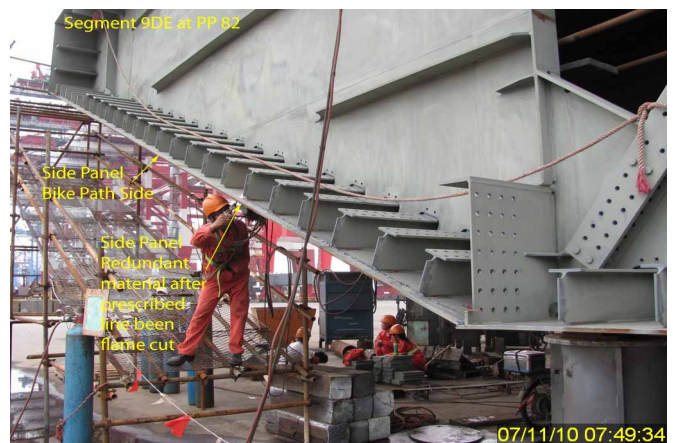
This QA Inspector witnessed the final bolt tension verification on bolts connecting the Partial Height Diaphragm flange to the Side Panel at Panel Points (PP) 50, PP 51 and PP 53 for Segment 7BE. The QA Inspector verified the bolt tension on a random basis and the results appeared to be in general compliance. The Inspection was performed against Notification No. 00418 dated July 11, 2010.

This QA Inspector witnessed the final bolt tension verification on bolts connecting the Cat Walk between Panel Points (PP) 62 and PP 63 for Segment 8AW. The QA Inspector verified the bolt tension on a random basis and the results appeared to be in general compliance. The Inspection was performed against Notification No. 00418 dated July 11, 2010.

This QA Inspector observed the in-process welding by Shielded Metal Arc Welding (SMAW) process on a Complete Joint Penetration (CJP) groove weld. The Weld joint was designated as OBE9C-003. The welder identification were 037932, 067765 and 066179 and observed welding in the 4G (Overhead) position using approved Welding Procedure Specification WPS-B-P-2214-B-U2-FCM-1. The piece mark was identified as Bottom Panel transverse splice. Please reference the pictures attached for more comprehensive details.

This QA Inspector observed that the ZPMC personnel were cutting the Side Panel using the mechanical guided flame cutting torch on the pre-scribed lines for Segment 9DE at Panel Point (PP) 82 Bike Path side. Please reference the pictures attached for more comprehensive details.
